Manhole Inspection Summary

Manhole # S29MM_023MH

Insp Date: 7/11/07 9:12 AM

Location Address: **608 RESERVOIR ST**

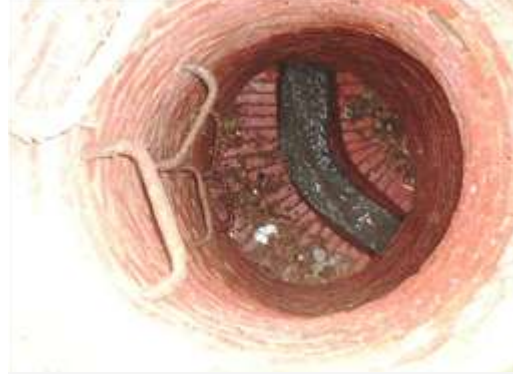
Top View

Corroded steps. Evidence of surcharge - Bench debris.

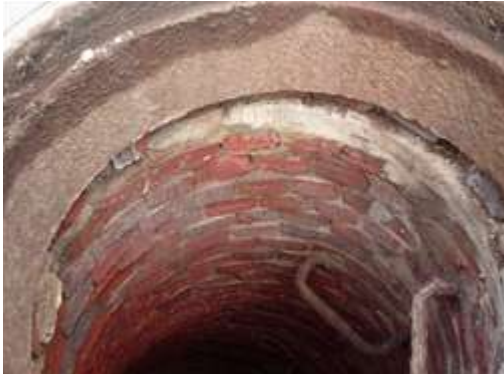
Defect

Frame leaks. Adjustment deterioration, loose brick and infiltration. Barrel infiltration - other side.

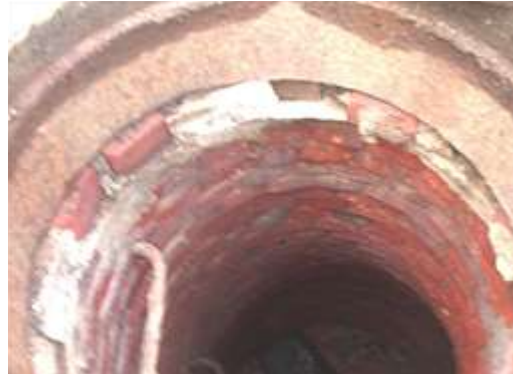
Defect

Frame leaks. Adjustment deterioration, loose brick and infiltration. Barrel infiltration.

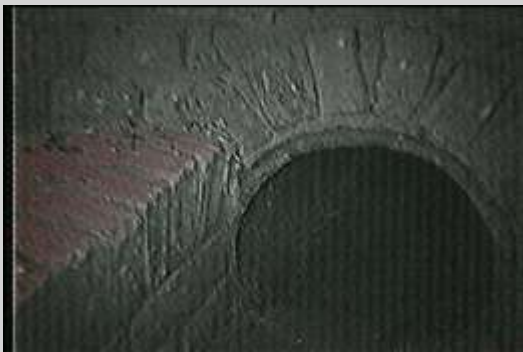
12 in. Circular Gravity Sewer Pipe Out @ 12 O'Clock

Infiltration: **Evidence** Pipe Seal Cond: **Unknown**

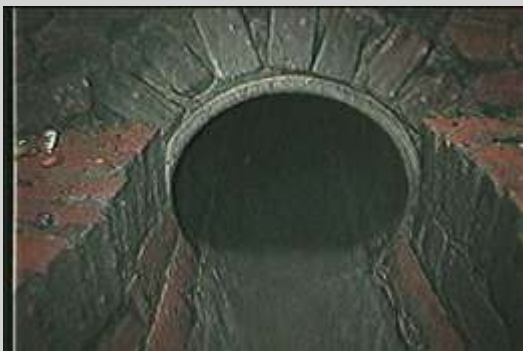
12 in. Circular Gravity Sewer Pipe In @ 7 O'Clock

Channel deterioration.

Infiltration: **Evidence** Pipe Seal Cond: **Cracked**
